EMBARCADERO SEAWALL MHRA OVERVIEW

SF Lifelines Council

MHRA PRESENTATION

EMBARCADERO SEAWALL MHRA

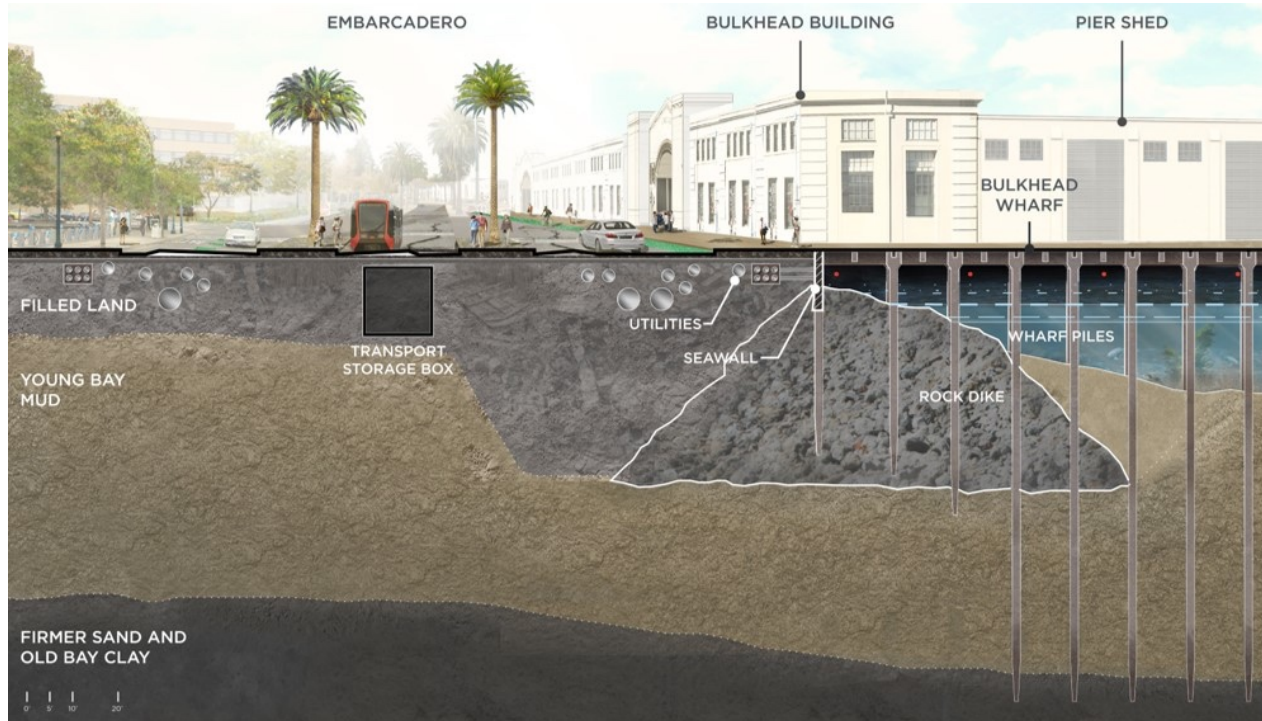
Critical Components of the Waterfront

- Filled land late 1800's to early 1900's
- Seawall retains filled soils containing Embarcadero corridor, connects piers to land, and provides water depth for maritime berthing.
- Seawall and Bulkhead Wharves provide Port and City flood and shoreline protection.

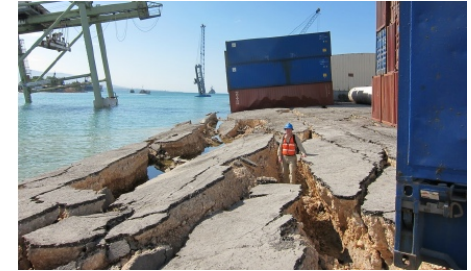
Liquefaction induced lateral spreading at Port de Port-au-Prince

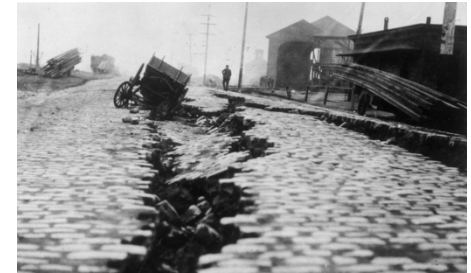
Lateral spreading cause by 1906 earthquake in San Francisco

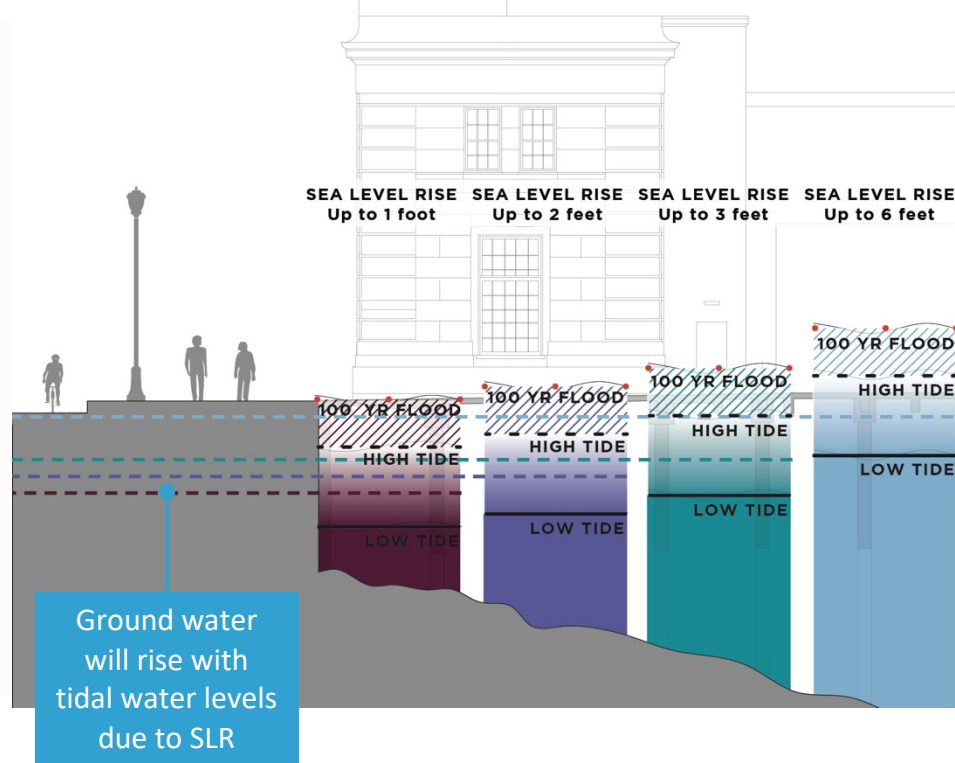
Ground water will rise with tidal water levels due to SLR

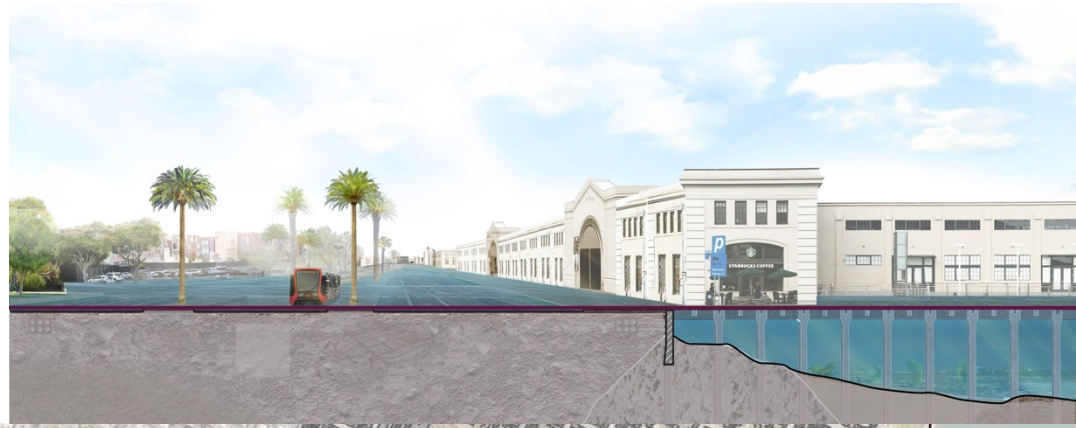
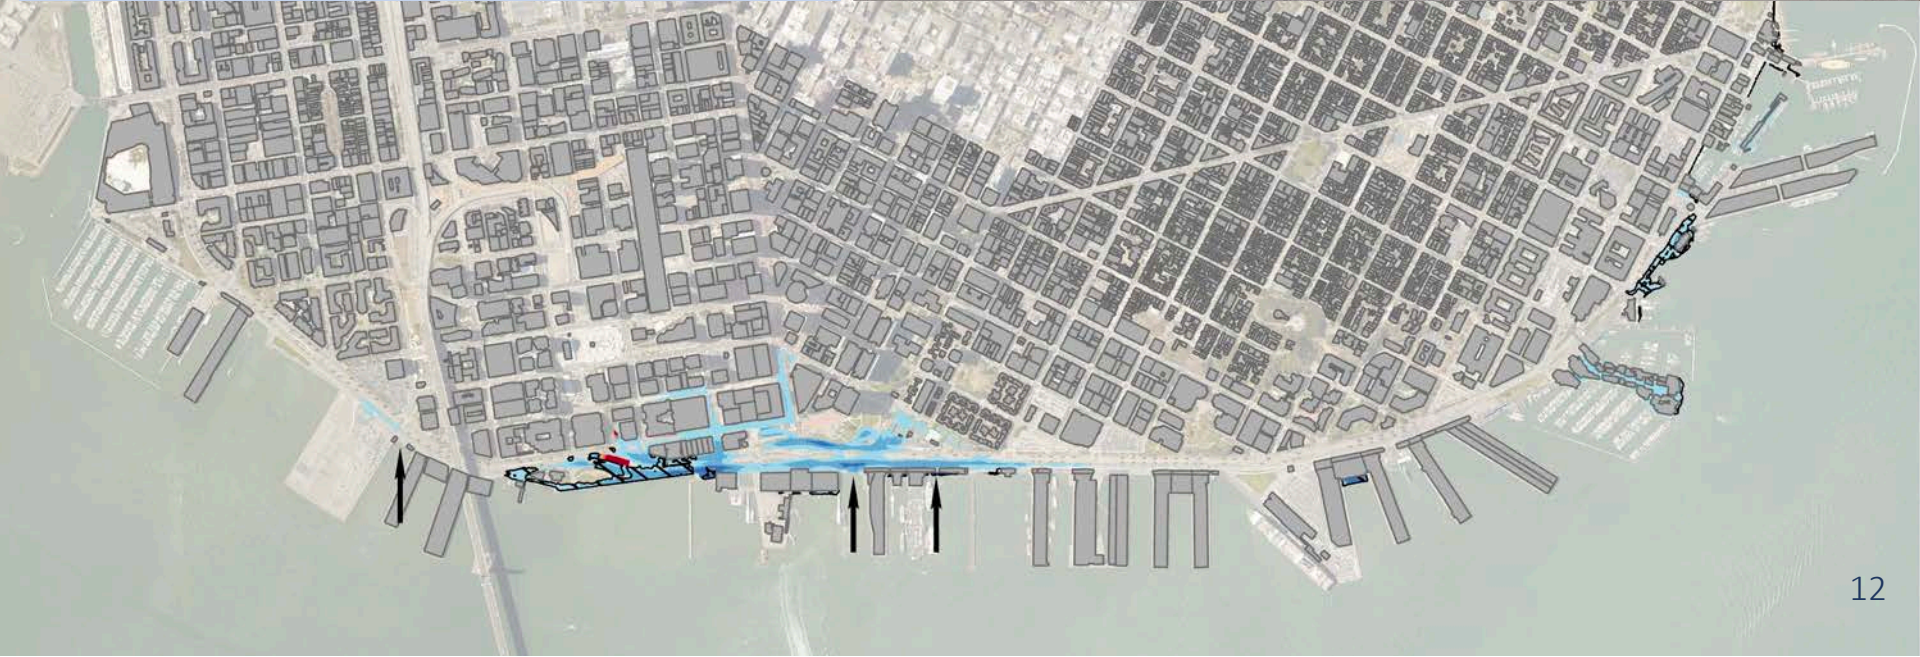
1 FT OF SEA LEVEL RISE (2035 – 2055; 15 to 35 yrs)

- 100yr Coastal Flood Extents Shown
- Daily high tides: similar to King Tides today
- Ground water rise 1 ft to 6 ft below surface, impacts some utilities

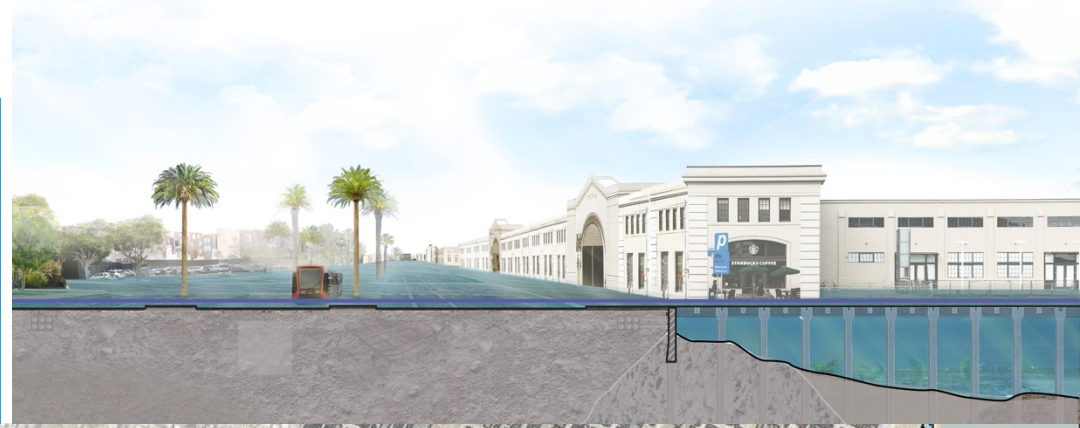
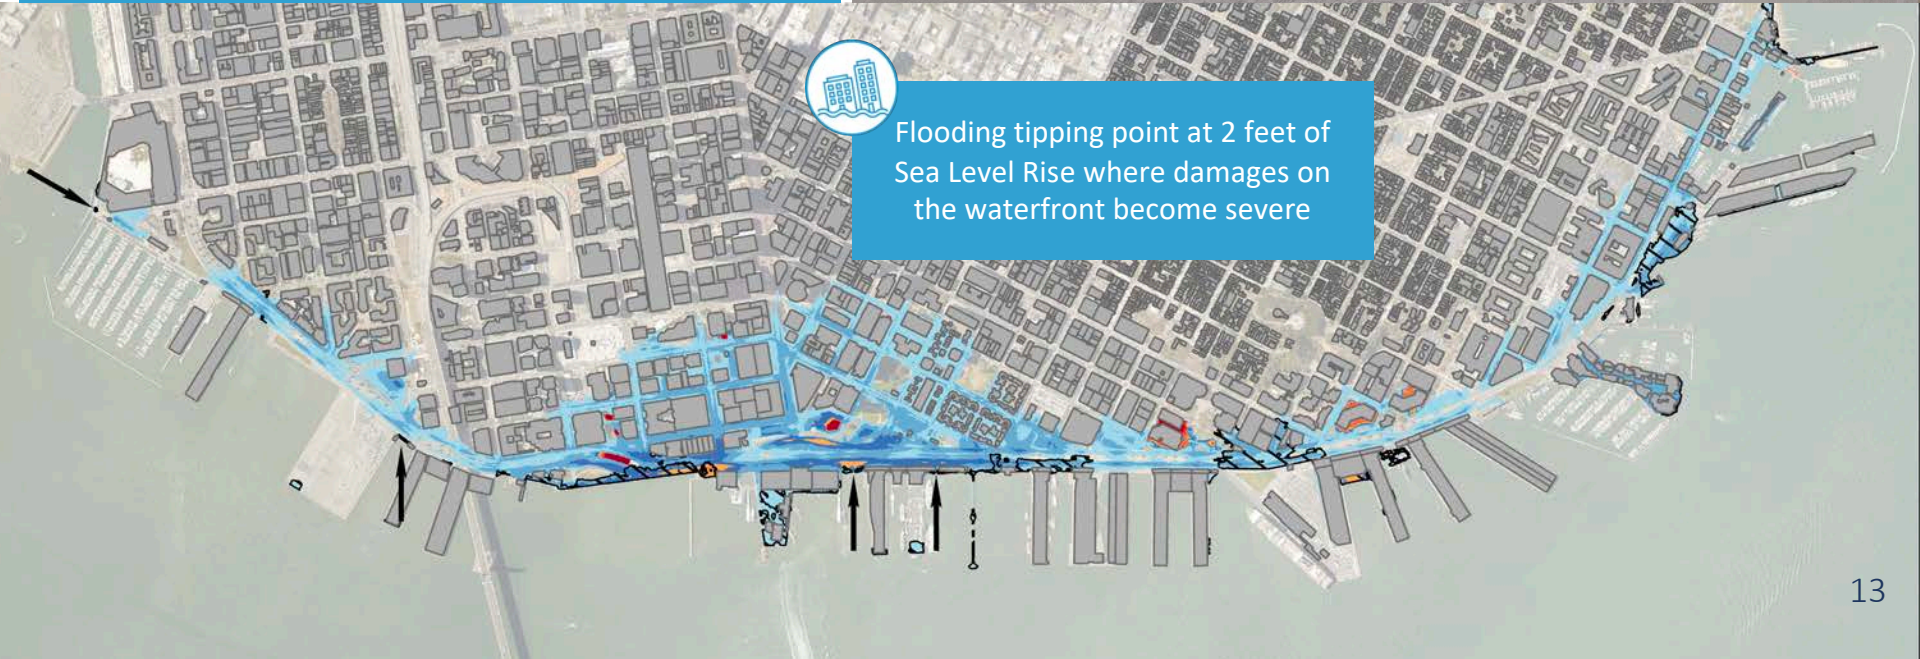
2 FT OF SEA LEVEL RISE (2050 – 2070; 30 to 50 yrs)

- 100yr Coastal Flood Extents Shown
- Daily high tides: waves overtop Pier 5 to Rincon Park & impact northbound Embarcadero
- Ground water rise by 2 ft to 5ft below surface, impacts utilities and roadway/LRT subgrade

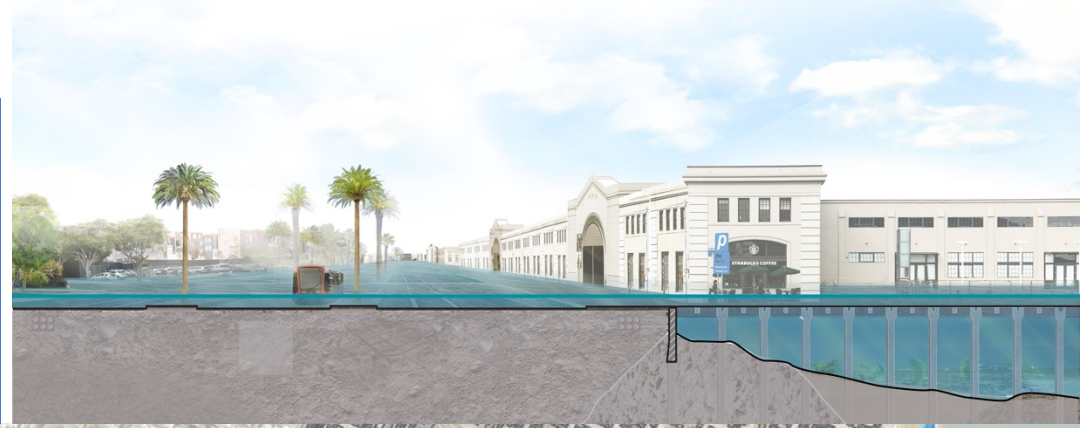
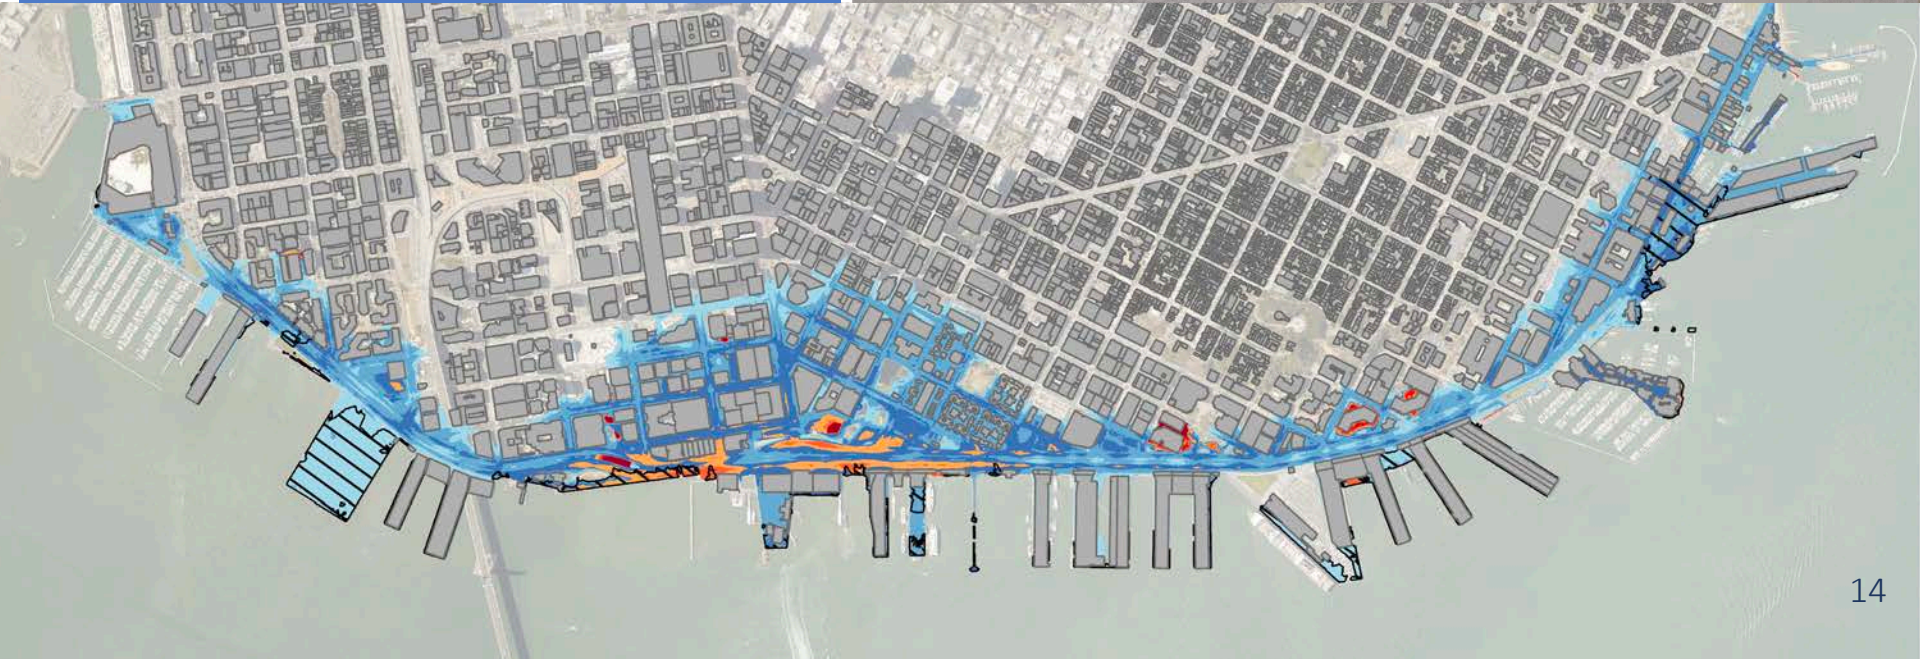
3 FT OF SEA LEVEL RISE (2065 – 2100; 45 to 80 yrs)

- 100yr Coastal Flood Extents Shown
- Daily high tides: inundate northbound Embarcadero
- Ground water rises 3 ft to 4ft below surface, impacts utilities and roadway/LRT subgrade

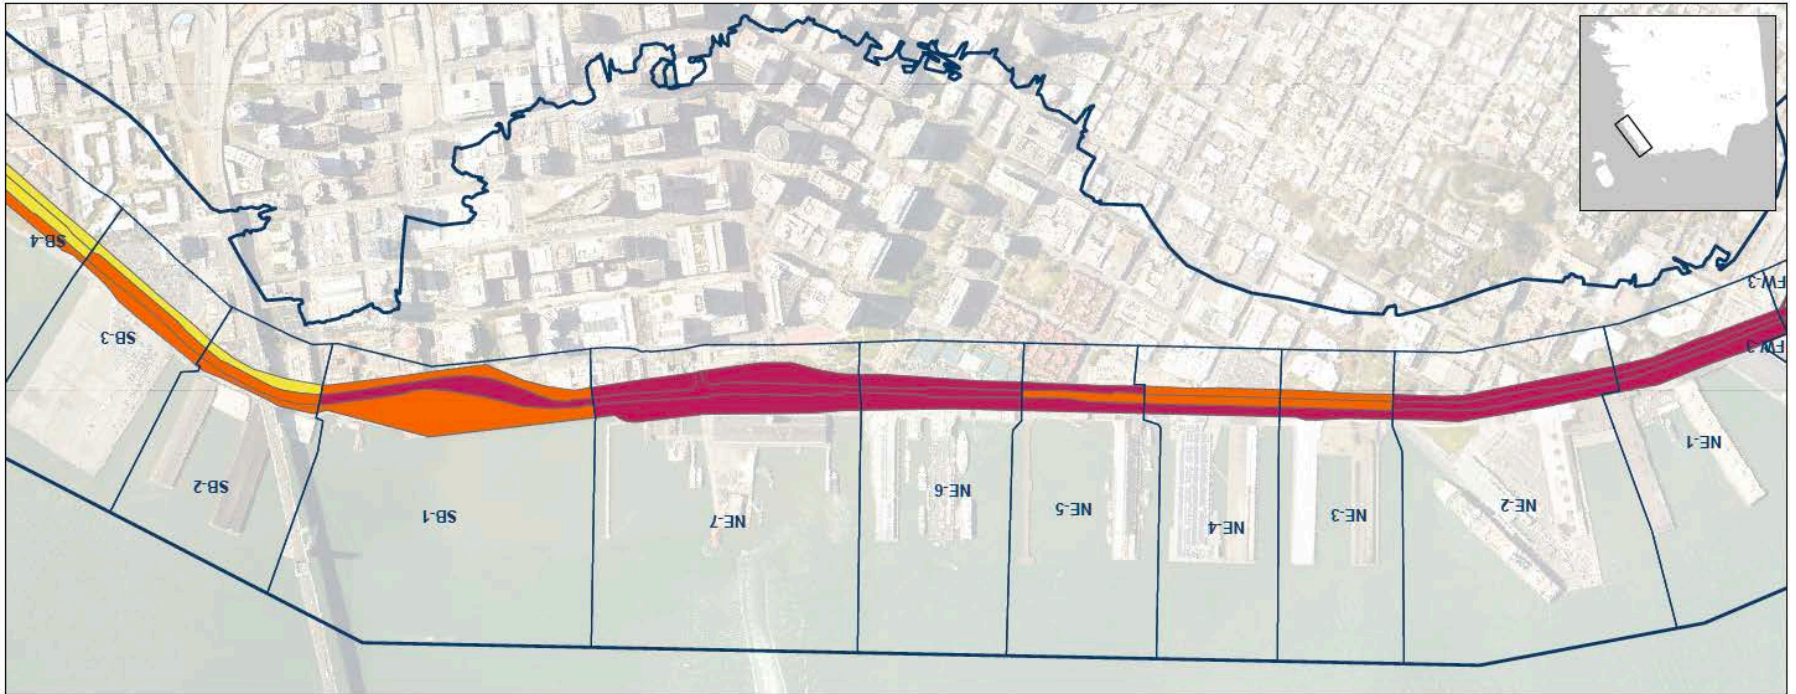
EARTHQUAKE DAMAGE ESTIMATE, Transit (225-yr level)

Transit Damage State: None, Slight, Moderate, Extensive
per Seawall Reach (Northbound, LRT/Median, Southbound)

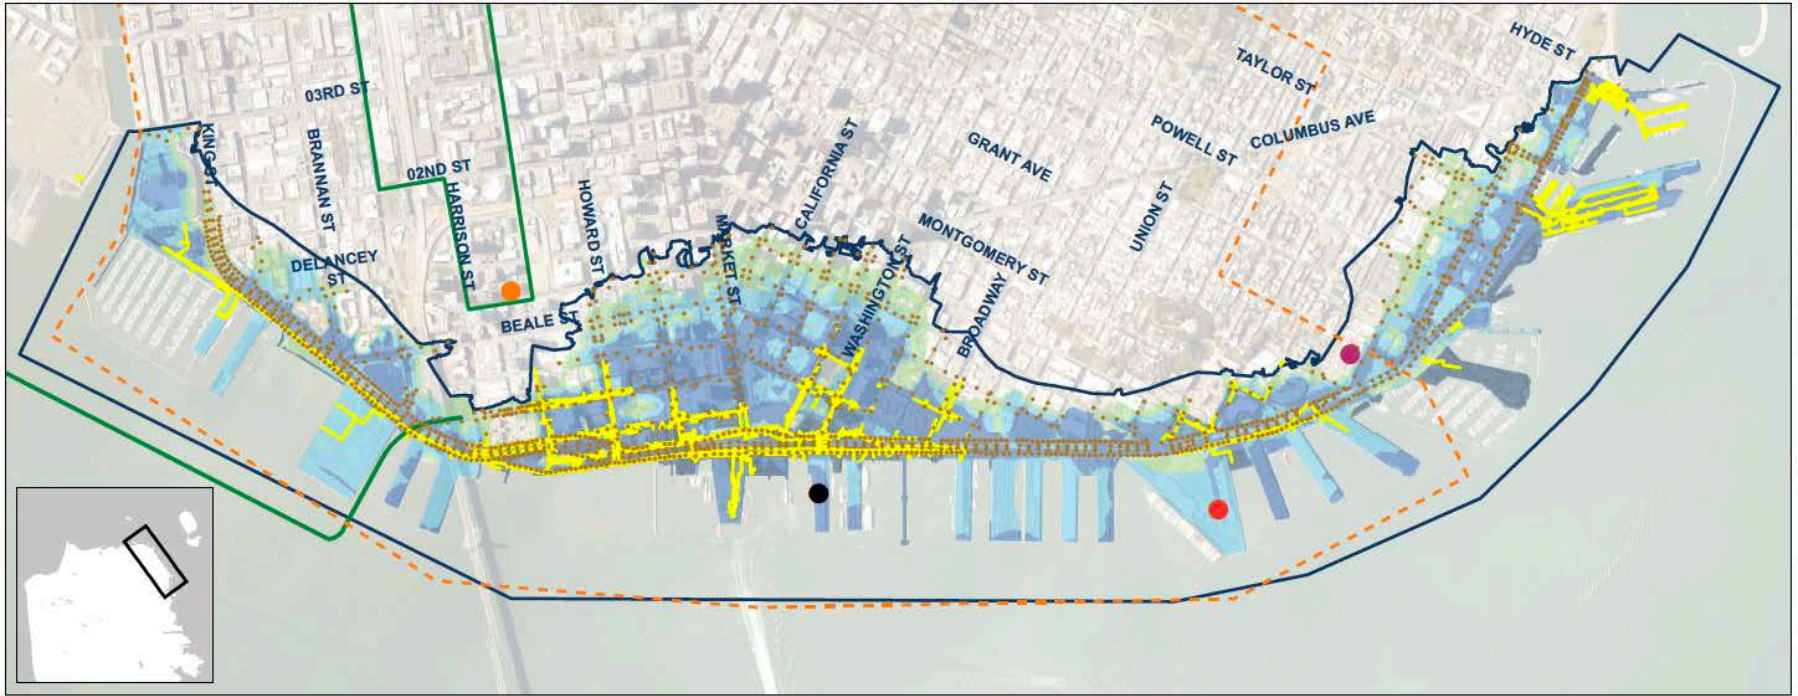
COASTAL FLOODING, Electrical System Exposure

Electrical System Asset Exposure at Various Water Levels
 No Damage Estimates

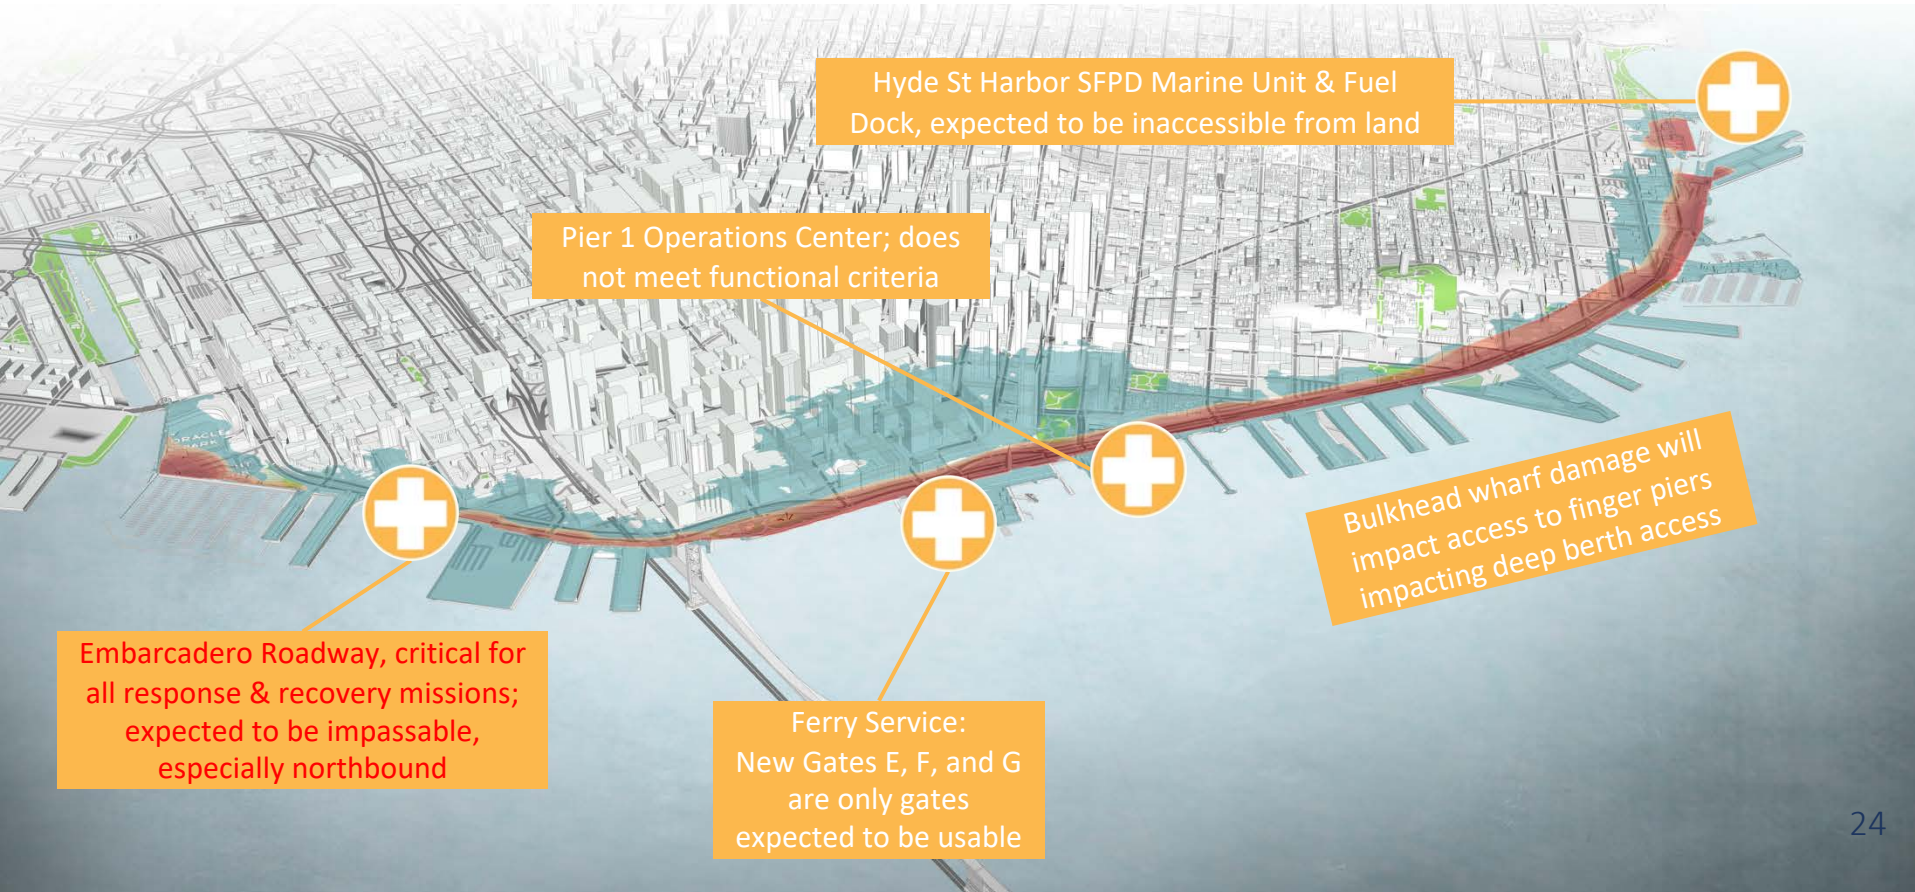
DISASTER RESPONSE – Earthquake Only

Hyde St Harbor SFPD Marine Unit & Fuel Dock, expected to be inaccessible from land

Pier 1 Operations Center; does not meet functional criteria

Embarcadero Roadway, critical for all response & recovery missions; expected to be impassable, especially northbound

Ferry Service:
New Gates E, F, and G
are only gates
expected to be usable

Bulkhead wharf damage will impact access to finger piers impacting deep berth access

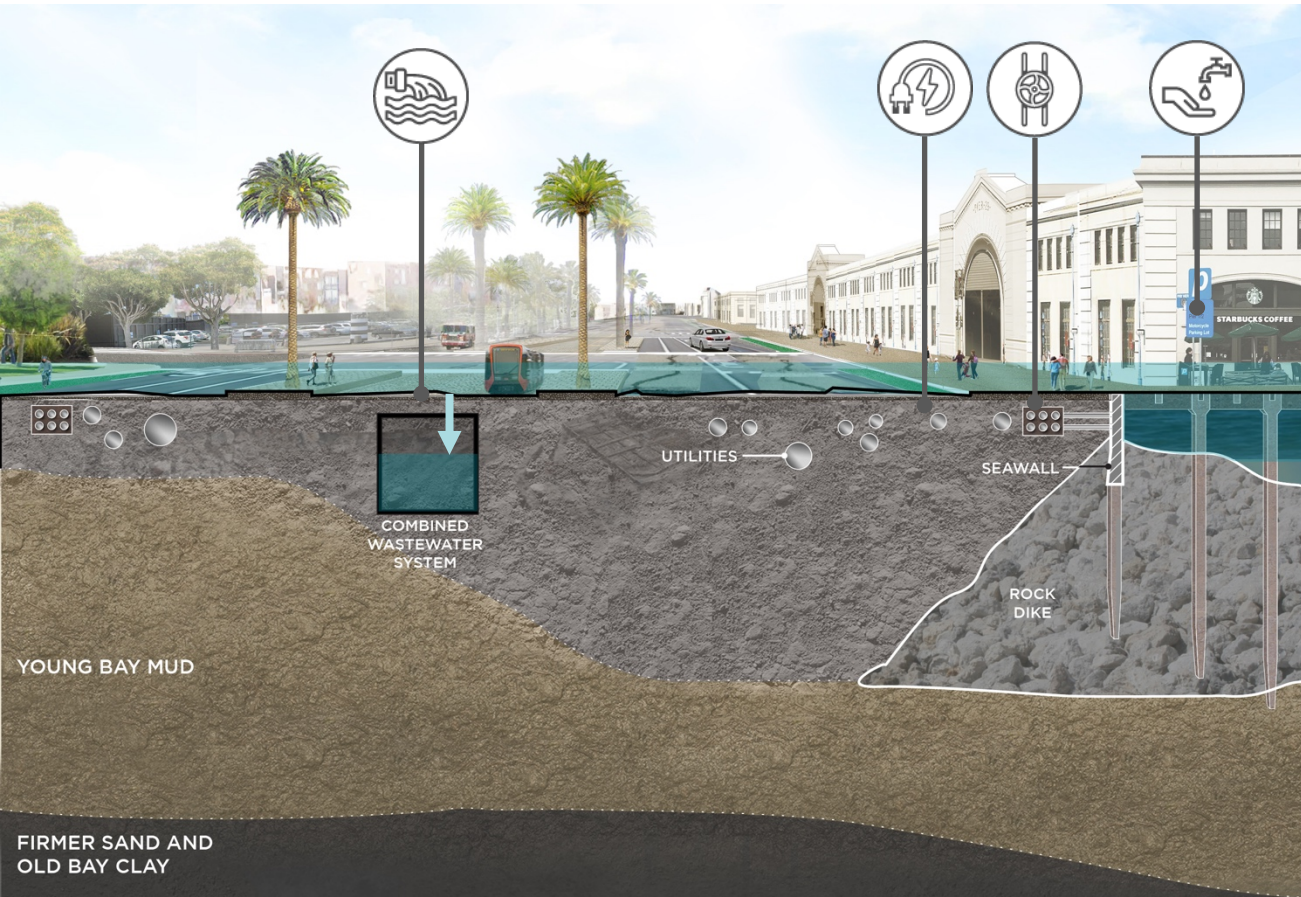
UTILITIES

Damage from both Seawall instability & liquefaction of fill

High damage in 100yr earthquake, sewer & water primarily, may take up to 1 year to repair

Critical City serving combined wastewater infrastructure at risk

Gas service breaks at seawall can lead to fire loss.

Function of Wastewater system will be impaired with 1ft of SLR and overwhelmed at 2ft of SLR

Saltwater damage to electrical equipment

Groundwater impacts with 2ft of SLR

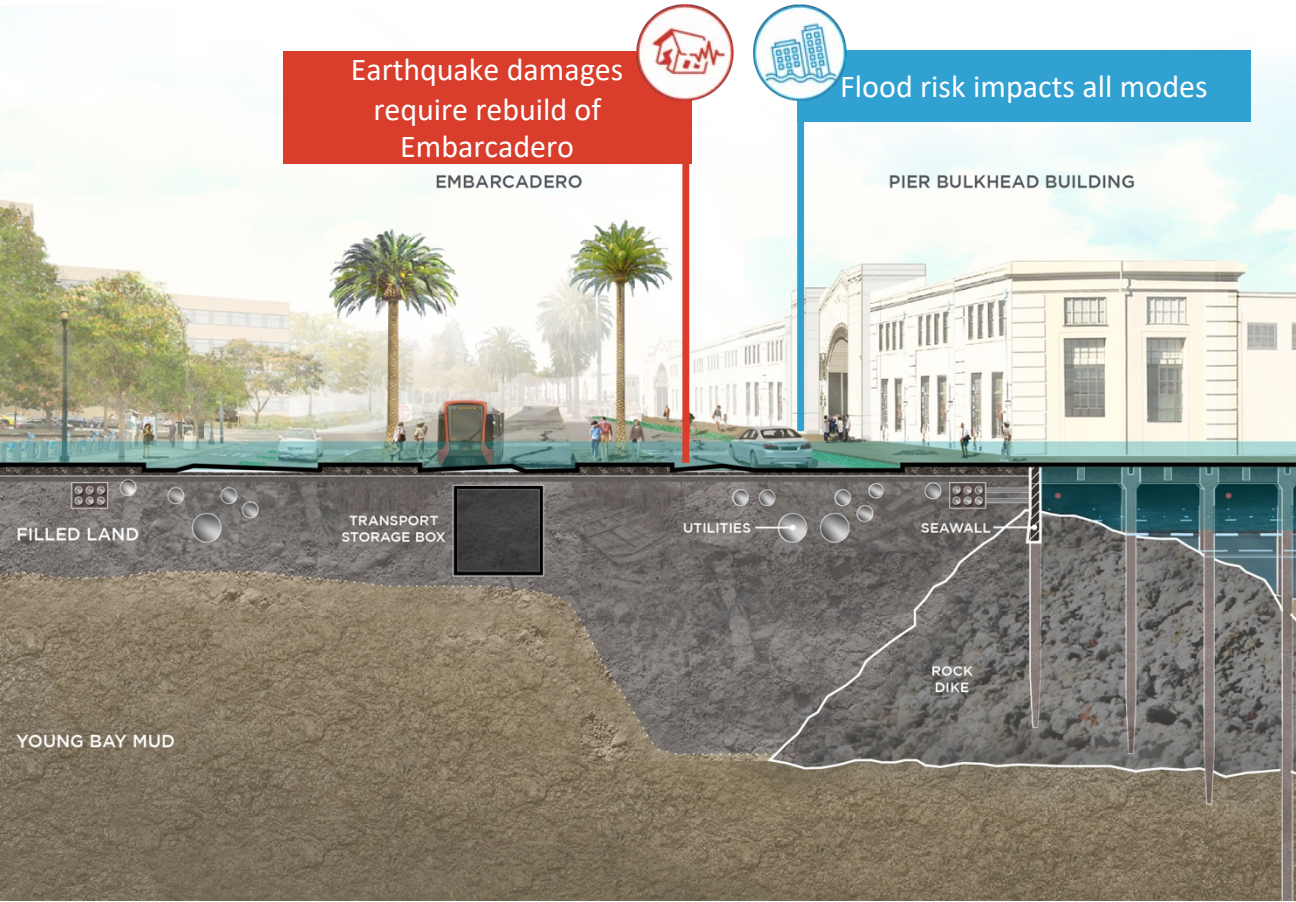
TRANSPORTATION

Earthquake damages require rebuild of Embarcadero

Damage from both Seawall instability & liquefaction of fill

High damage in 100yr earthquake combined with utility repairs, may cause disruption for 1+ year

Severe damage in 225yr earthquake may cause disruption for 2+ years.

Northeast waterfront, northbound lanes, and Promenade expected to see higher damage.

BART & MUNI, moderate disruption with 1ft of SLR & major disruption and damage with 2 ft SLR; 460,000 trips with regional impact.

Groundwater rise will begin damaging subgrade at 2ft of SLR.

Embarcadero severely impacted by 2ft of SLR.

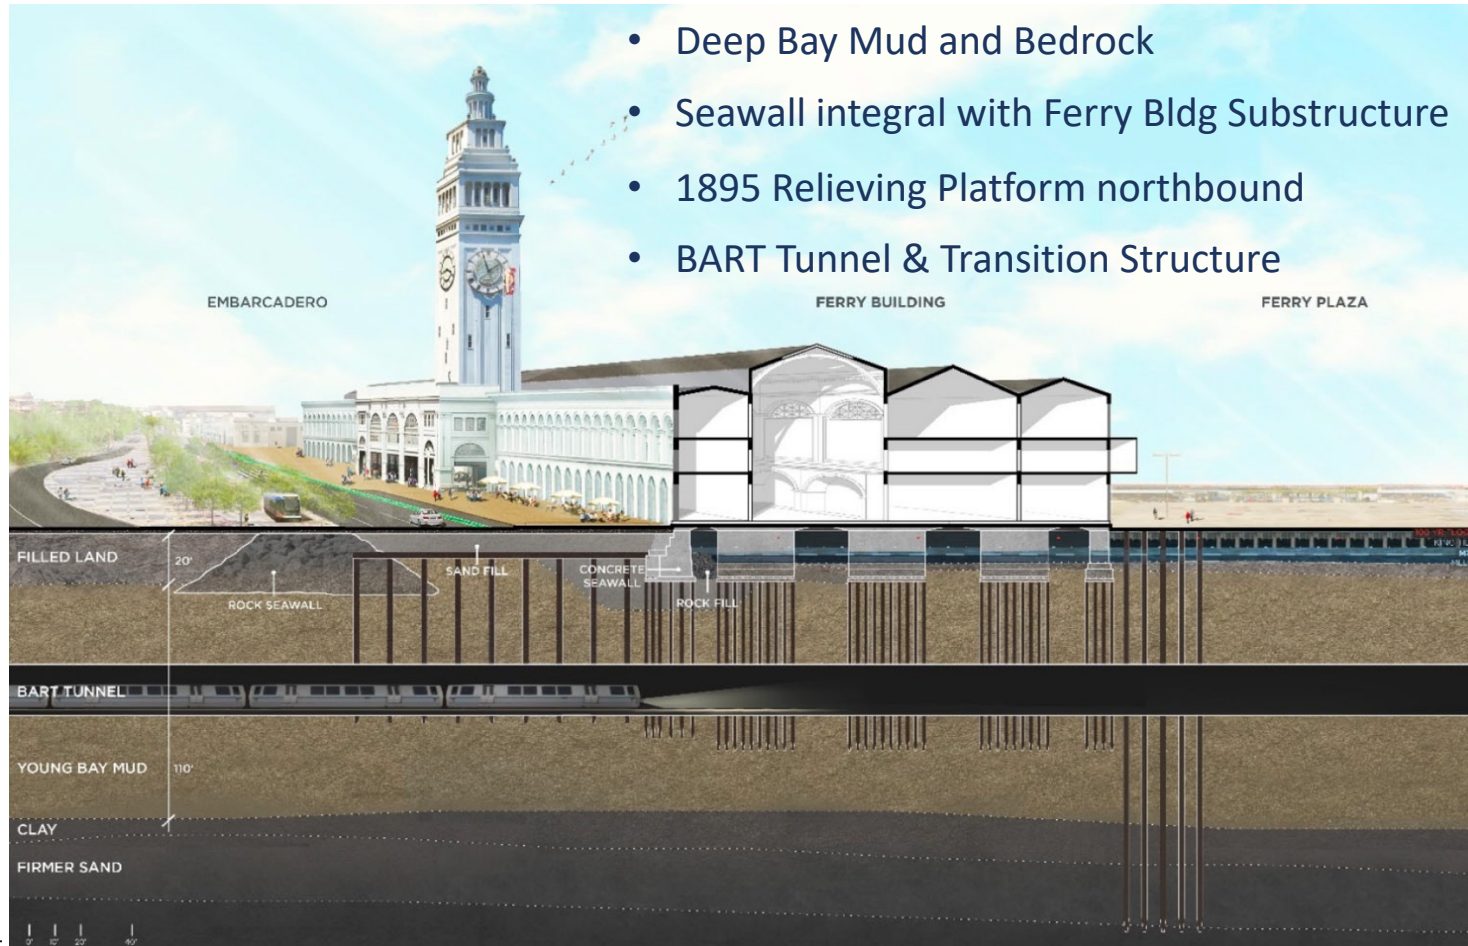
FERRY BUILDING AREA COMPLEXITIES

- Deep Bay Mud and Bedrock
- Seawall integral with Ferry Bldg Substructure
- 1895 Relieving Platform northbound
- BART Tunnel & Transition Structure

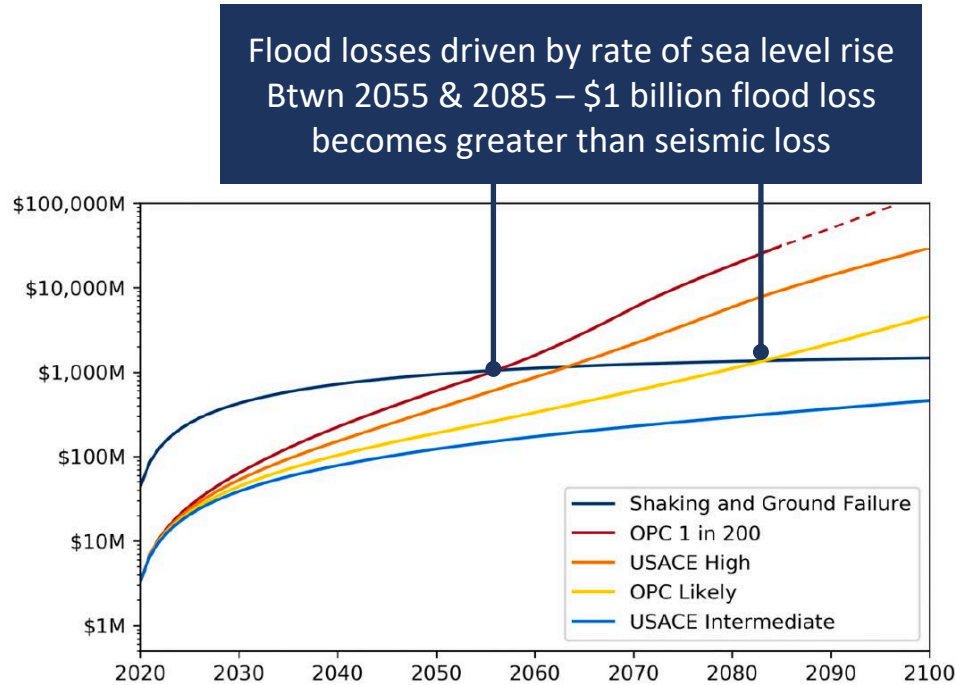
Figure 5-1. Total Economic Impact Present Value Losses for the Embarcadero Seawall Program Area

Note: Figure includes buildings, marine structures, mobility, and regional cascading impacts.

- **Near-term economic damages mainly from earthquakes:** \$940 M in estimated earthquake losses over 30 yrs increasing to \$1.5B over 80 yrs
- **Longer-term economic damages from sea level rise:** flood losses increase from \$190 M in 30 years to \$4.5 B in 80 years with the likely SLR scenario, and to \$30 billion with the high SLR scenario. Significant damages are outside of Port.
- As we saw with the recent Pier 45 fire, damages can have major impacts on people, businesses, jobs, and more
